***GENERAL LAYOUT***  
***SITKA***

# Sitka Ferry Terminal

5307 Halibut Point Road

**Owner:** State of Alaska

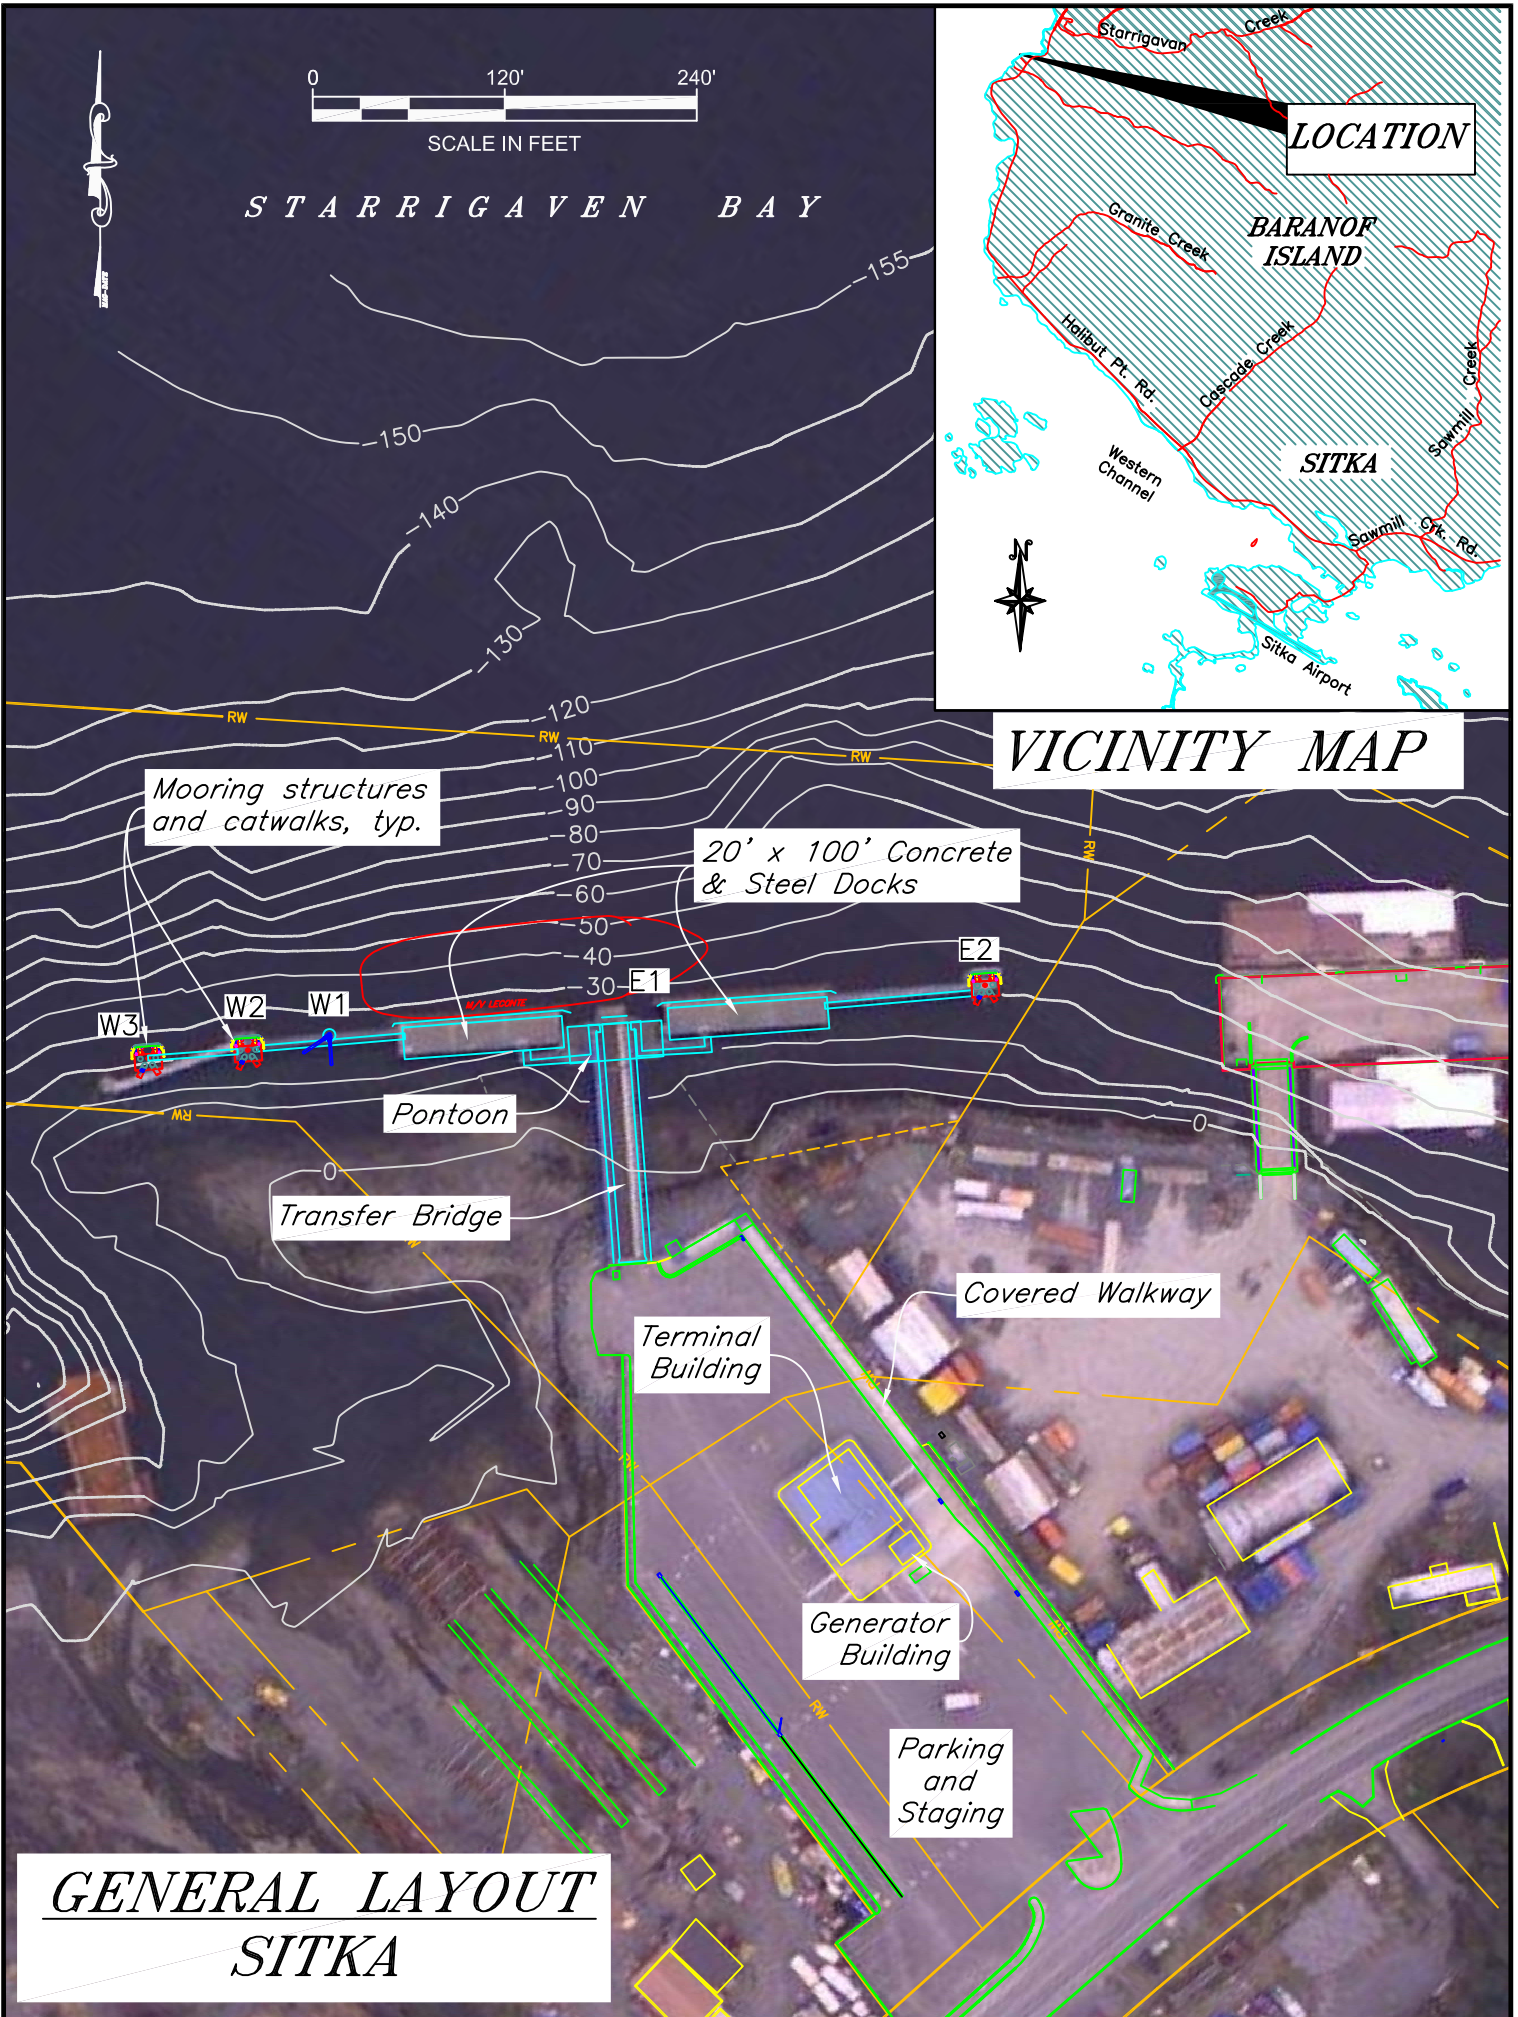
*Mooring structures and catwalks, typ.*

*20' x 100' Concrete & Steel Docks*

Pontoon

Transfer Bridge

Terminal Building

Covered Walkway

Generator Building

Parking and Staging
